FANCHER CREEK DAM FRESNO, CALIFORNIA

EMBANKMENT CRITERIA AND PERFORMANCE REPORT

JULY 1994

DEPARTMENT OF THE ARMY SACRAMENTO DISTRICT, CORPS OF ENGINEERS SACRAMENTO, CALIFORNIA

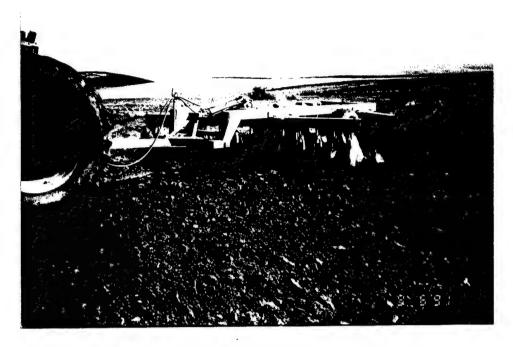
Photo 17 Disc used to process the soil. 15 Oct. 1990

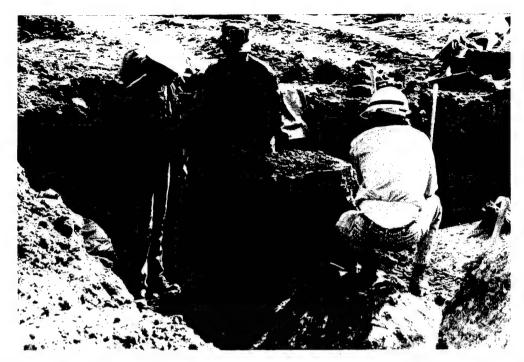
Photo 21 Early stages of carving undisturbed sample for record sample program. 3 Dec 1990

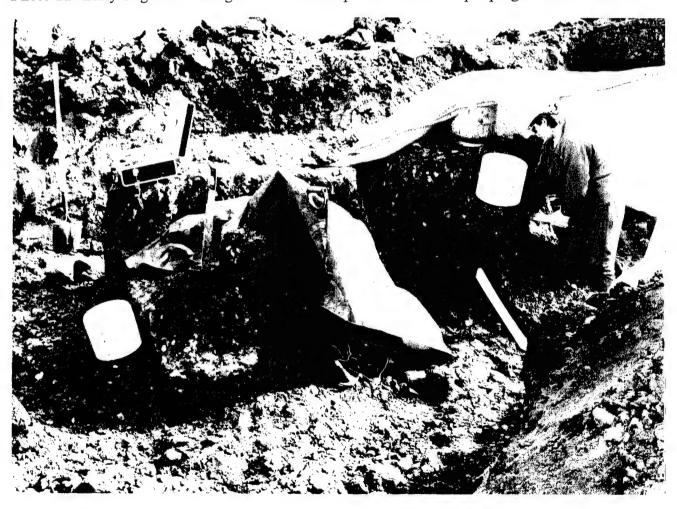
Photo 22 Final sizing and shaping of undisturbed sample prior to encapsulating in PVC tube. 3 Dec. 1990

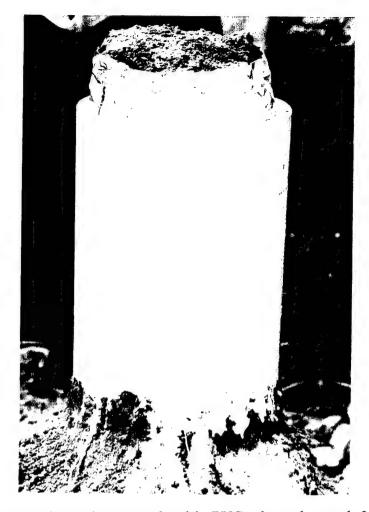
Photo 23 Record sample encapsulated in PVC tube and waxed. 3 Dec. 1990

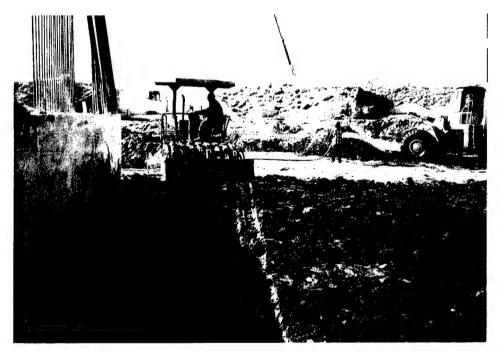
Works structure (Photographs 24 through 27). Graphs showing a summary of the construction control data for this earth work are shown on Plates 28 through 30.

Photo 24 The clay material being compacted, and in the background the clay is being moisture conditioned.

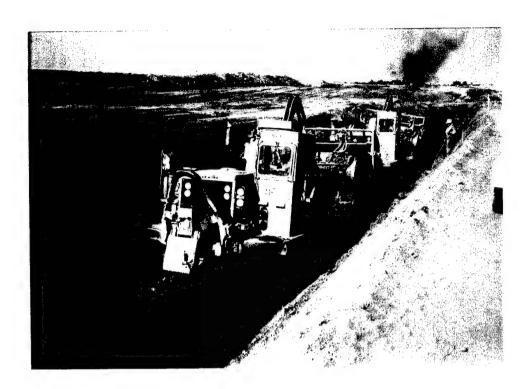
Photo 2 Dam Station 48+60, rock in foundation was blasted and removed. 28 Sept. 1990

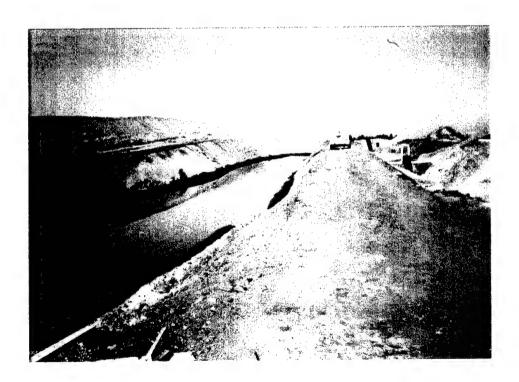
Photo 4 Inspection Trench, Stations 102+00 and 128+00 prior to dewatering. 23 Oct. 1990

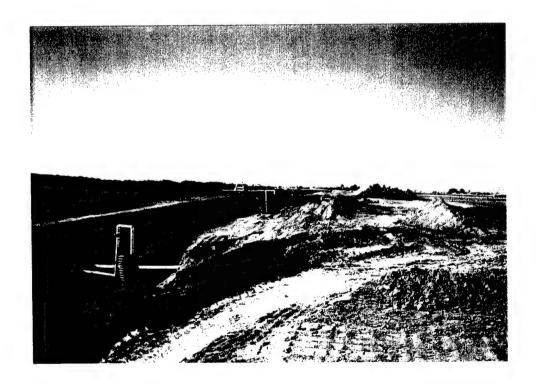
Photo 6 Dewatering system between Dam Stations 102+00 and 128+00. 20 Oct. 1990

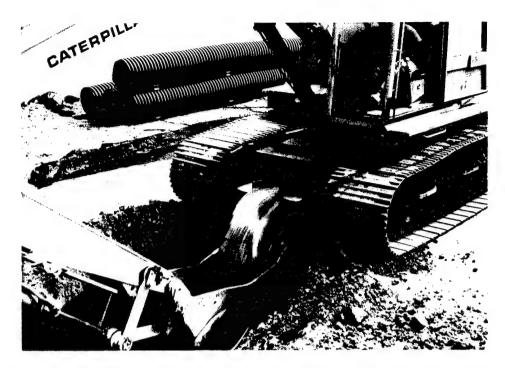
Any minor seepage through the embankment and upper foundation will be collected in the horizontal blanket and toe drain. The horizontal drain blanket was constructed of 18 inches of gravel (drain rock) and protected with 9 inches of sand (filter material) encapsulating the top, bottom and the upstream end. The horizontal drain blanket was placed on the dam foundation, 17 feet downstream of the dam centerline and daylights at the downstream toe. It starts at Station 53+70 and ends at Station 158+10. The toe drain was constructed adjacent to and downstream of the downstream toe. It is 4 feet wide and extends below the ground surface to elevation 457.0 feet at it's beginning (Station 53+70), elevation 457.5 feet at it's end (Station 158+10) and elevation 442.3 feet at the outfall point (Station 76+00). The location of the toe drain is shown on Plates 9 through 24. The toe drain is lined with filter fabric which encapsulates the drain rock backfill. When the toe drain intercepts seepage, water is transported to the foundation low point in a 24-inch-diameter perforated, high density polyethylene, corrugated pipe (Photographs 7 and 8). The water is then discharged under the Friant-Kern Canal via a cross drain syphon.

- c. <u>Toe Drain</u>. The toe drain was excavated between Stations 53+70 and 158+10 with a Caterpillar 235 excavator, geologically mapped as shown in the Foundation Report and constructed as shown in Photographs 7 and 8. Where hard rock was encountered a process called "hydraulic fracturing" (not to be confused with hydraulic fracturing of soil) was used to obtain the required grade. This process involved drilling 4-inch-diameter holes approximately 3 to 4 feet into the rock, inserting the mechanical apparatus into the hole, and then injecting the hydraulics into the apparatus with high pressure, at which time it spread thus splitting the rock (see the Foundation Report for details).

Photo 7 Cat 235 Excavator, placing pipe bedding material in the Toe Drain. 29 Aug. 1990

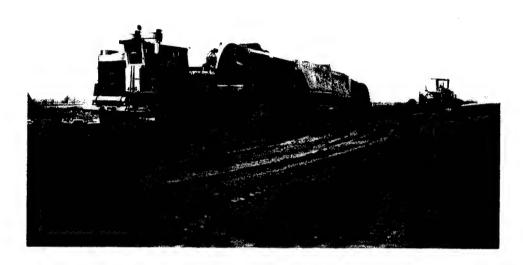
Photo 15 Holland Wagon dumping soil on fill, grader spreading the material. 15 Oct. 1990

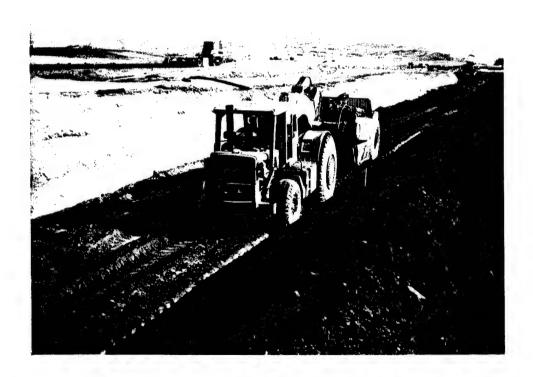
- b. Random Fill. The foundation was stripped and prepared for fill (Photographs 1 and 2). This also required the blasting and removal of a large granitic knob (no alluvium under it) (a hard, very large boulder remaining after the surrounding granitic rock had weathered) at Station 48+60. An attempt was made to moisture condition the borrow sites (Photograph 9). However, due to the type of excavation used (the Holland Excavator can cut up to 13 feet deep at one time) this was not effective (Photograph 10). Random fill for the embankment was excavated and loaded by a Holland excavator into the Holland belly-dumps (Photographs 11 through 14). The material was then hauled to the damsite for processing and compaction (Photograph 15). Water was added to the random material and the disks worked it in to obtain a well blended material at near optimum moisture content (Photograph 17). Random material was spread in lifts which, after compaction, had an average thickness of 6 inches. Lift thickness was controlled by visual inspection and with the use of hand levels. After spreading, water was added using a water wagon. Each lift of fill was compacted with three passes of a vibratory roller (Photograph 19). After compaction, the surface of the fill was scarified to a depth of 2 to 3 inches with a 32-inch-diameter disk-plow to provide proper bonding for the subsequent lift. Random Fill also came from the inspection trench and diversion channel excavations. They were excavated using Caterpillar 660 scrapers and push dozers. When soft material was encountered Caterpillar 637 scrapers were utilized, as shown in Photograph 3. The inspection trench excavation between Stations 102+00 and 128+00 required excavating below the groundwater table (Photograph 4). A dewatering system was installed as discussed in the Foundation Report (Photographs 5 and 6). After the inspection trench was inspected and geologically mapped, backfill began with Caterpillar 660 scrapers (Photograph 16).

Photo 16 Cat 660 scraper dumping fill in the inspection trench. 15 Oct. 1990
